# Manhole Inspection Summary

Manhole # S47C\_\_004MH

Insp Date: 7/11/08 1:14 PM

**Location** Address: **Paterson Park**

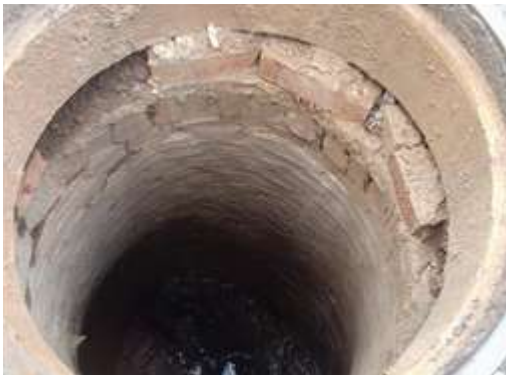
Defect 1

☒ **Loose Brick**

☒ **Mortar**

loose brick

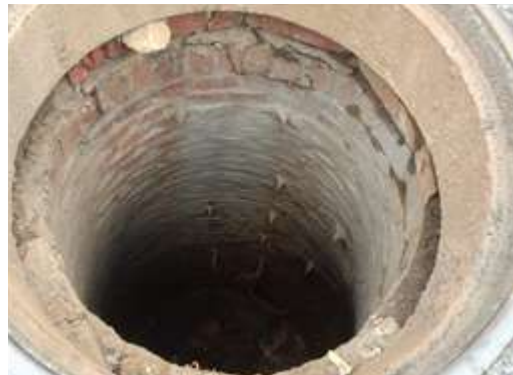
Defect 2

☒ **Leaks**

frame leaks

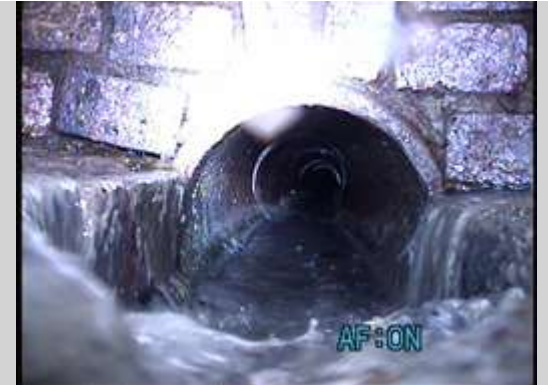
12 O'Clock Outflow

8 in. Circular Gravity Sewer  
Pipe Out @ 12 O'Clock

Pipe Height: **4.8** (in.) Rod and Bar  
Pipe Material: **Clay** ☐ Pipe Lined  
Invert Depth: **9.95** (ft.) Flow Characteristics: **Fast**  
Deposits: ☒ None ☐ Mud ☐ Sludge ☐ Debris ☐ Grease  
Silt Depth: (in.) Deposits Extent:  
Infiltration: **None** Pipe Seal Cond: **Sound**

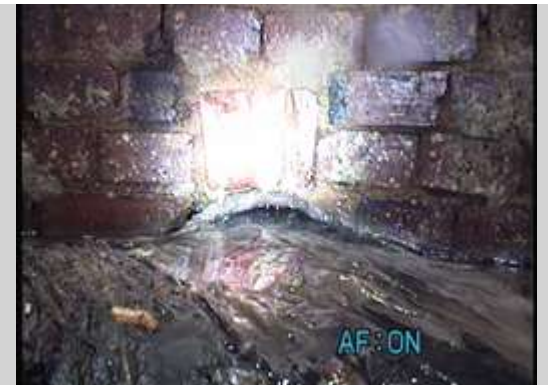
3 O'Clock Inflow

8 in. Circular Gravity Sewer  
Pipe In @ 3 O'Clock

Pipe Height: **8.4** (in.) Rod and Bar (Angled)  
Pipe Material: **Clay** ☐ Pipe Lined  
Invert Depth: **10.50** (ft.) Flow Characteristics: **Fast**  
Deposits: ☒ None ☐ Mud ☐ Sludge ☐ Debris ☐ Grease  
Silt Depth: (in.) Deposits Extent:  
Infiltration: **None** Pipe Seal Cond: **Sound**

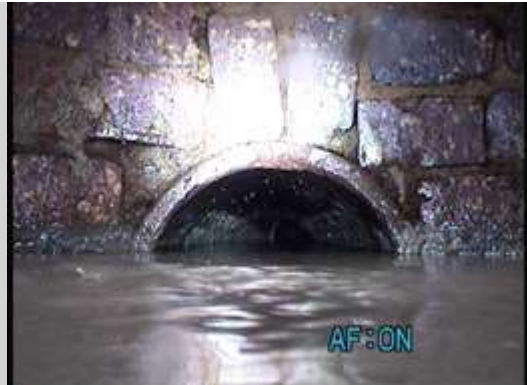
6 O'Clock Inflow

8 in. Circular Gravity Sewer  
Pipe In @ 6 O'Clock

Pipe Height: **8.4** (in.) Rod and Bar (Angled)

Infiltration: **None** Pipe Seal Cond: **Sound**
